**LIMITED LEAD-BASED PAINT SURVEY DRAFT REPORT  
2018**

MONTGOMERY COUNTY PUBLIC SCHOOLS  
Fairland Center  
13313 Old Columbia Pike  
Silver Spring, MD 20904

PSI Project Number 04481290

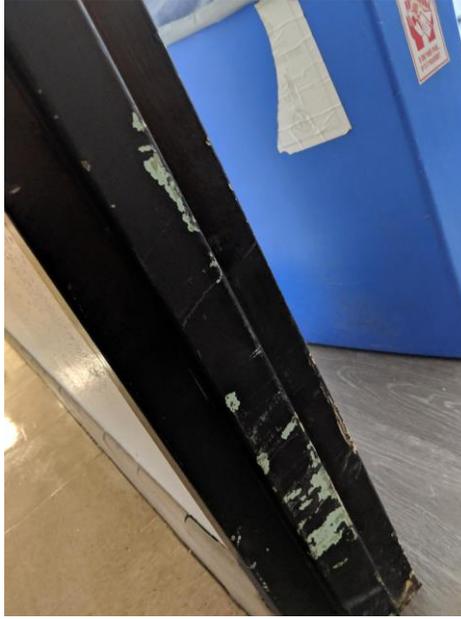
**Photo 1: Deteriorated black paint on metal door jamb  
(Negative XRF reading)**

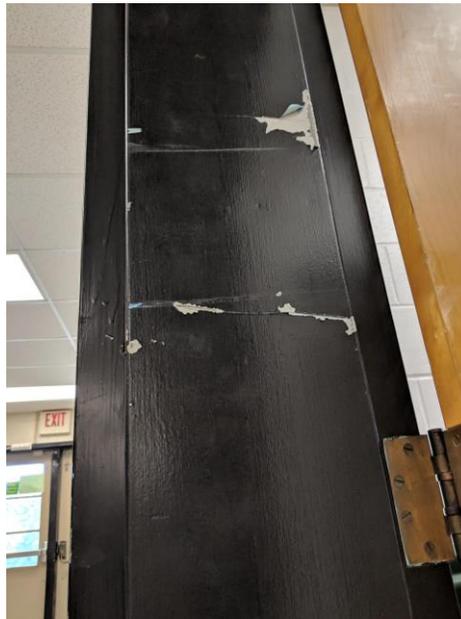
**Photo 2: Deteriorated black paint on metal door casing  
(Negative XRF reading)**

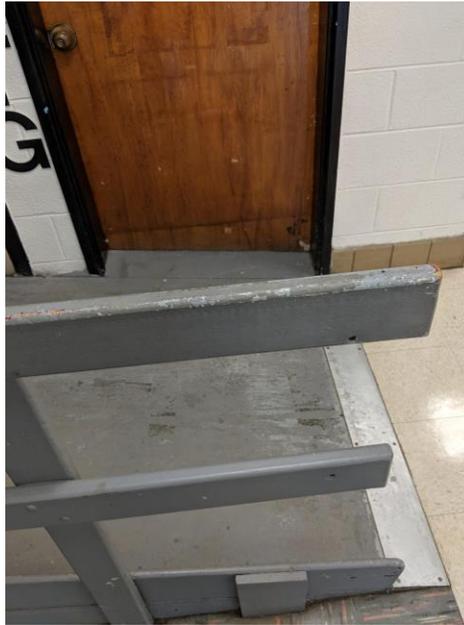
**Photo 3: Deteriorated grey paint on wooded ramp handle  
(Negative XRF reading)**

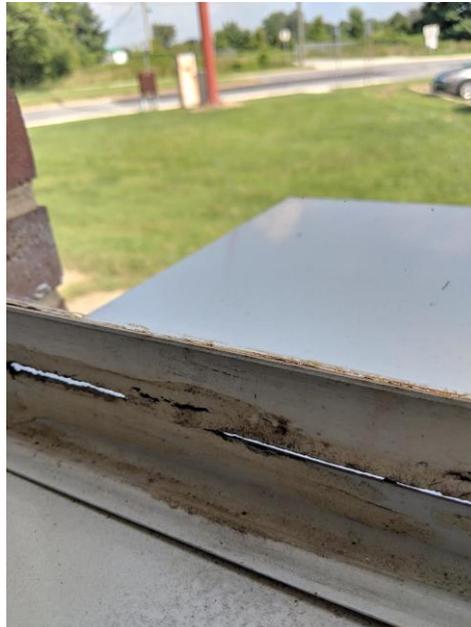
8/28/2018	128	Interior	Multipurpose Room	Window Casing	C	Metal	White	Deteriorated	0.8
8/28/2018	147	Interior	Staff Lounge	Pole		Metal	Black	Deteriorated	5.0

**Photo 4: Deteriorated white paint on metal window casing  
(Positive XRF Reading)**

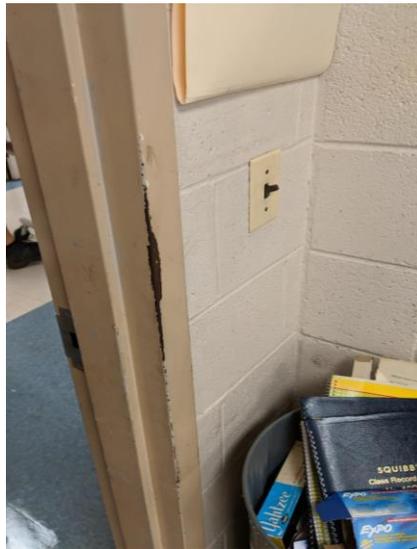
**Photo 5: Deteriorated white paint on metal door casing and jamb  
(Negative XRF Readings)**

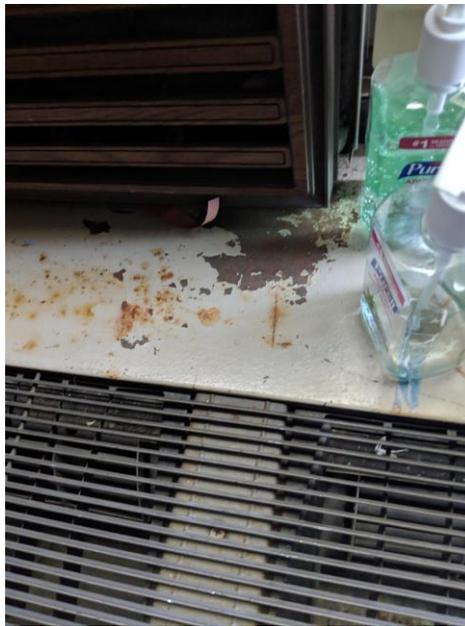
**Photo 6: Deteriorated white paint on metal window sill  
(Negative XRF Readings)**
