Ref: **Sampling for Asphalt Fumes and Hydrogen Sulfide Gas – 4/18/2023**  
Poolesville High School  
KCI Job No. 122302497

KCI Technologies Inc. (KCI) is submitting the following letter report detailing the findings of air sampling of Asphalt Fumes (benzene soluble fraction) and Hydrogen Sulfide gas at Poolesville High School located at 17501 W. Willard Rd. Poolesville, MD 20837 (subject site). Sampling was conducted by KCI's Industrial Hygienist, Mr. Tyler McCleaf, CSP, under the oversight of KCI's Certified Industrial Hygienist (CIH), Mr. Jonathan Coale on April 18, 2023.

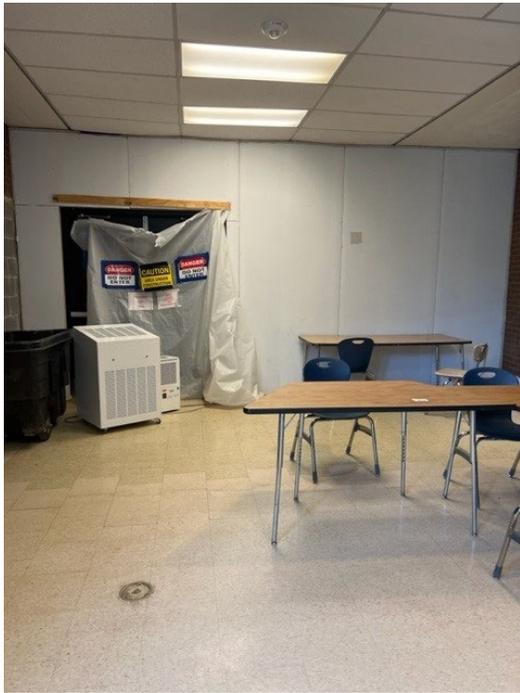
Photo 1: Auditorium Lobby (School Side)

1. Barrier outside auditorium, school side.
  - a. Poly covering door in disrepair, seams between barrier are not covered to prevent air movement.
  - b. Heavy asphalt smell present in corridor.

- KCI recommends all barriers between construction zone and school should be upgraded with two-layers of 6mm poly plastic sealed in place by duct tape or similar adhesion method. These recommendations should be applied to any construction zone / school entrance currently blocked for egress.

- For areas used as emergency exits, an additional two-layers of 6 mil poly will be applied to the door, the interior of the two layers will be cut vertically to allow movement through the emergency exit and the outer layer will only be adhered at the top allowing it to be moved aside in an emergency to gain access to the emergency exit, similar to the entrance to a 3-stage decontamination unit.

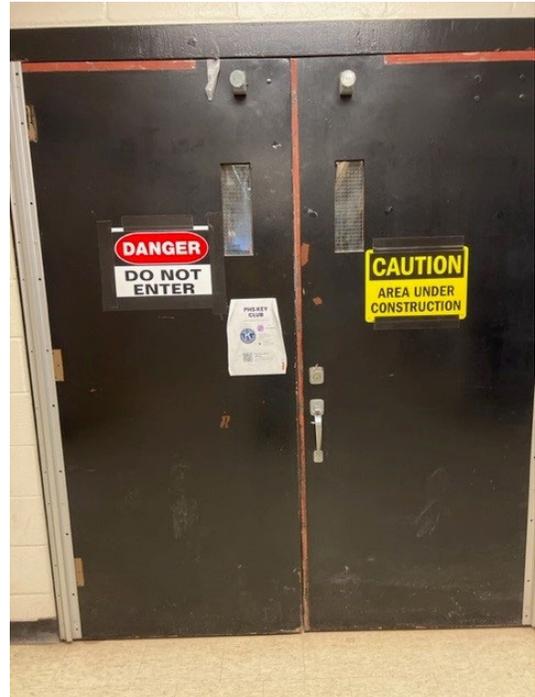
Photo 2: Door to Construction Site Outside Room 13 (School Side)

3. Door outside room 13, construction side:
  - a. Previous poly barrier was removed.
4. Door outside girls locker room, construction side:
  - a. No poly barrier erected.

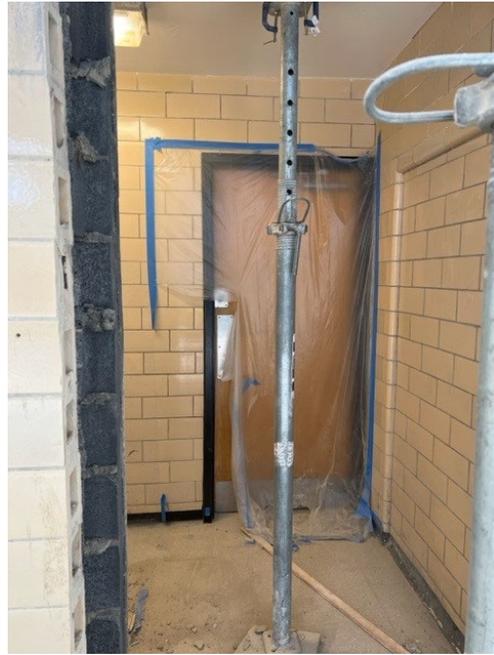
Photo 6: Door to Boys Locker Room (Construction Side)

5. Door outside boys locker room, construction side:
  - a. Poly barrier in disrepair.
6. Negative air enclosure, construction side outside auditorium lobby:

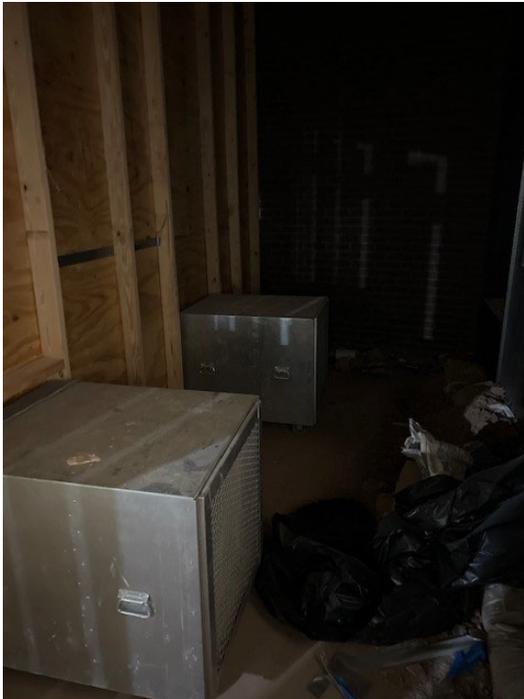
Photo 7: Containment Outside Auditorium Lobby (Construction Side)

- a. Two negative air machines were observed, one was unplugged and not working at time of barrier review.
  - b. Interior wall had some tape covering the seams but no poly barrier keeping out cross contamination.

- c. No H<sub>2</sub>S detected in containment.

- Upon review of the barriers, it was noted a negative air enclosure was constructed and two negative air machines were present. KCI recommends applying critical barrier construction on the outside of the plywood enclosure to ensure negative pressure is gained within the containment, both negative air machines should be running during asphalt roof activities.

- KCI recommends that the construction contractor routinely check integrity of barriers applied to these egress routes and ensure negative air machines are operational during working hours and to fix deficiencies as soon as possible.
